Analysis of damage origin of bevel gear wheels

The problem is solved for a single-stage bevel gearbox with curved teeth, which is part of the mechanism of a small hydroelectric power plant. Due to the frequent failure rate of the bevel gears, as well as to determine the damage, vibrations were measured on this assembly.

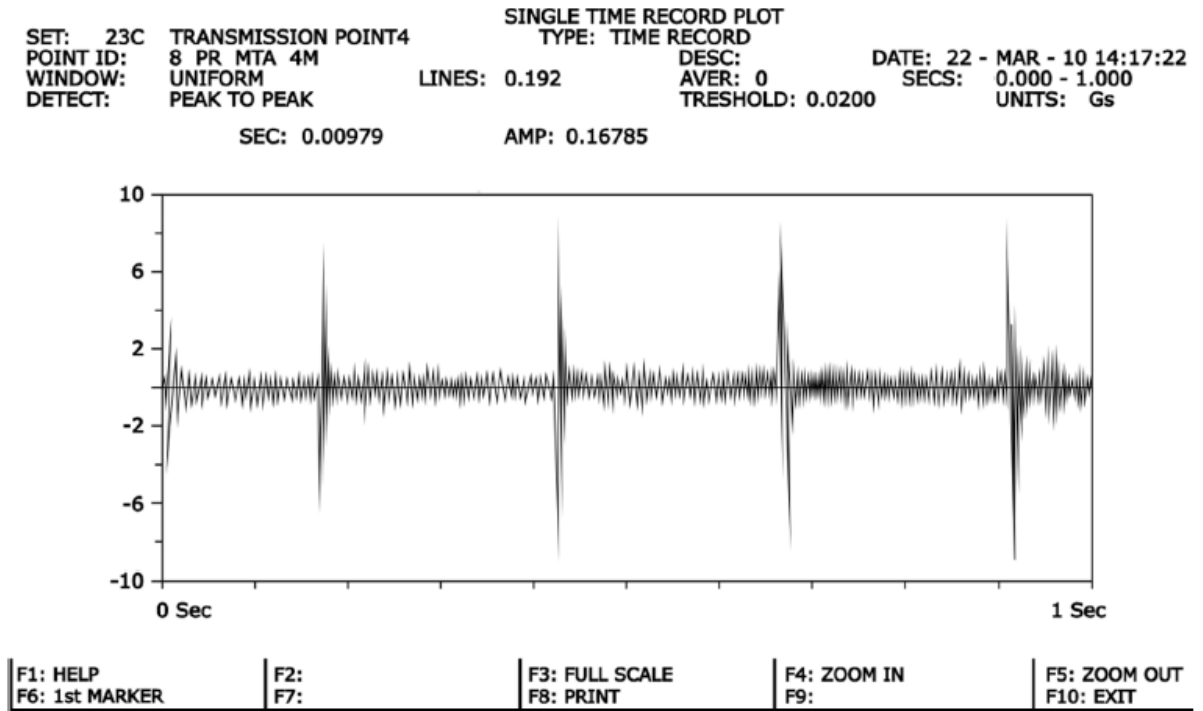
Fig. 7. Time vibration record - input shaft of bevel gearbox with bevel pinion.

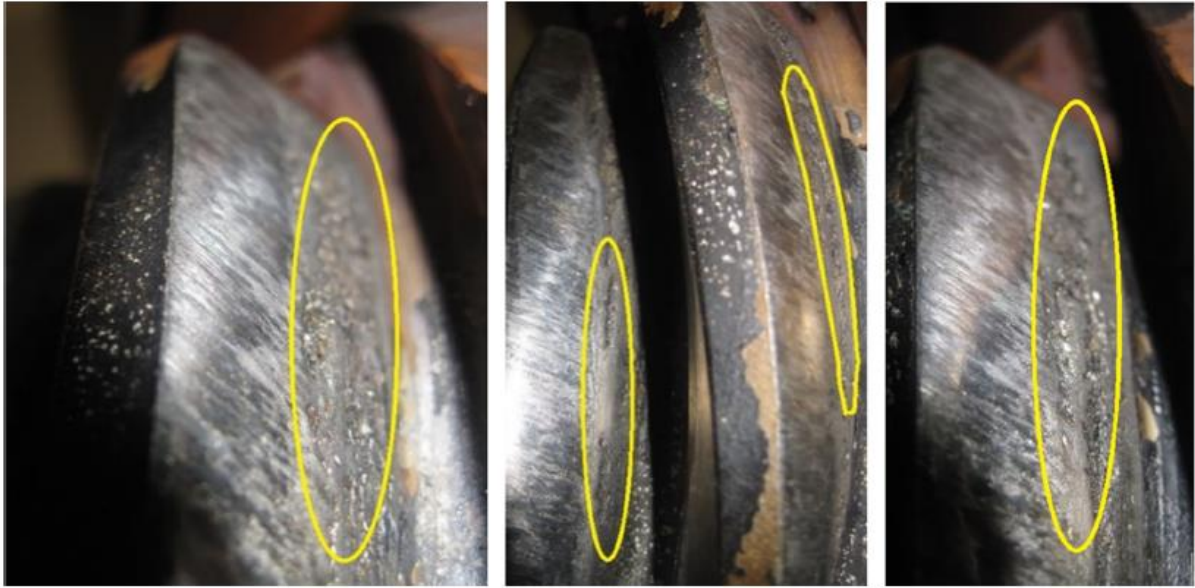
There are distinct, very large and prominent pits along the entire length of the tooth near the root of the tooth to a height of $\frac{1}{3}$ to $\frac{1}{2}$ of the tooth on each pinion tooth (**Fig. 8**). These are manifestations of surface fatigue. Damage is manifested by the removal of metal particles and the formation of cavities (pits). The pits are not due to wear, but to surface and subsurface stresses caused by the repeated application of forces. This damage occurs on contact as a result of rolling and sliding. This pitting corrosion occurs most commonly on heat-treated gearing. After breakage (chipping, peeling

off) of the small metal particles of the active surfaces of the tooth, the surface is left dotted with distinctive pits. Commonly and most often this pitting is manifested in the area of the pitch circle. In this case, the pitting, the pronounced pitting, manifested itself near the root of the tooth, which means that, the meshing conditions were broken.

Fig. 8. Pitting on the gearing of a bevel pinion.

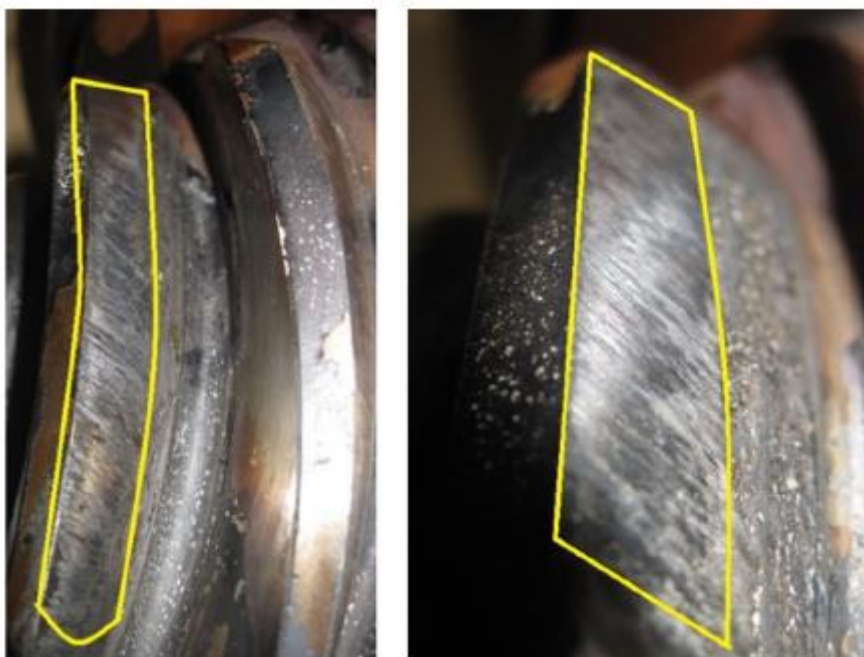
The spiral bevel pinion has distinct and deep grooves and indentations on the active sides of the teeth (applicable to all teeth of the pinion) in the part of the surface from $\frac{1}{3}$ of the height of the tooth up to the head of the tooth (**Fig. 9**). The formation of prominent grooves and indentations is due to plastic deformation and to wear of the tooth flanks.

This type of damage occurs on slow-speed gears where there is significant slip in the direction of the tooth contact line and generally in materials with low surface hardness. The pinion teeth are cemented and hardened according to the manufacturing drawing. The faces of all the teeth of the spiral bevel pinion are severely damaged by cold jamming. This type of damage is reversible as long as the mechanism of its origin is removed.

Fig. 9. Indentation - jamming of a tooth side.

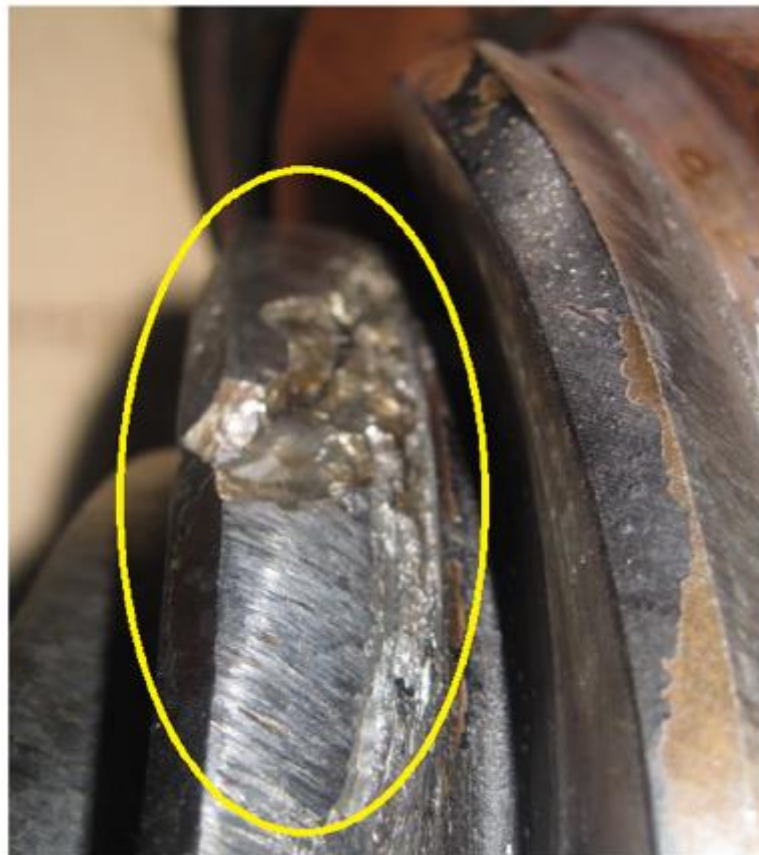
Three teeth of the bevel pinion out of a total of 12 are damaged by breakage of an irregular shape part of the side of the tooth located at the head area of the tooth. It is a deep damage to the flank of the active tooth surface by breaking out a portion of the tooth to a thickness of up to $\frac{1}{3}$ of the tooth profile (**Fig. 10**). It is a sign of fatigue fracture.

Fig. 10. Breakage of part of a bevel pinion tooth.

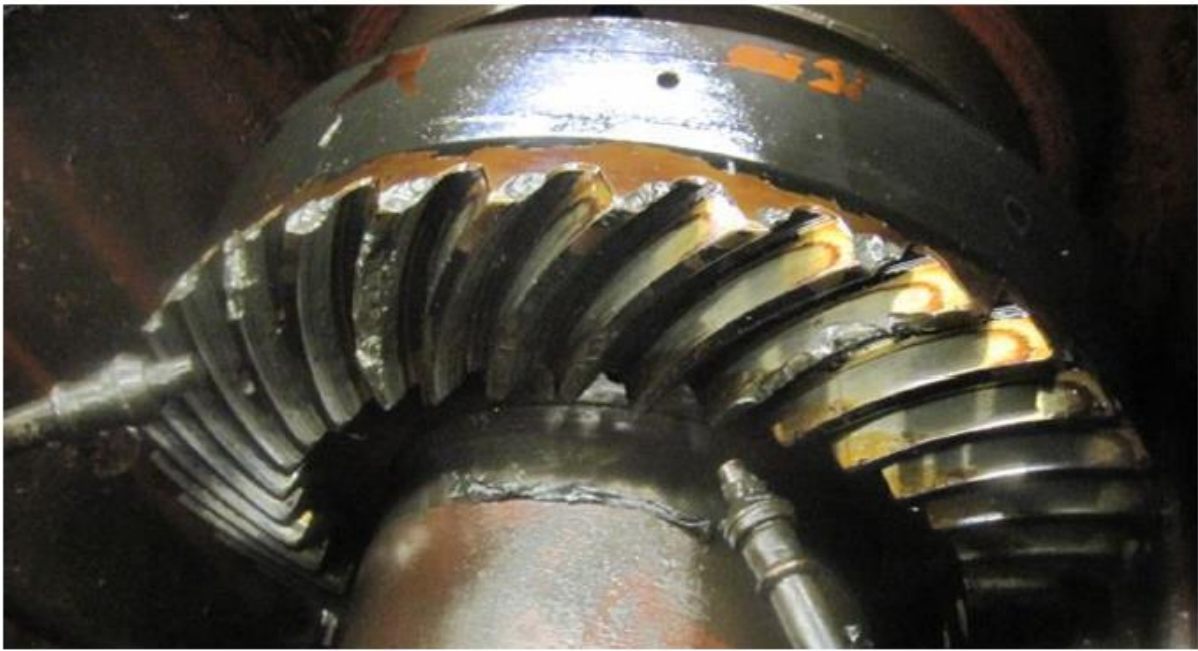
There was extensive damage to the gearing on the spiral bevel gear, not a single tooth was left intact (**Fig. 11**). Some teeth are broken off across the width of the tooth. Lubrication nozzles used for lubrication of meshed teeth can be seen on Figure. More detailed damage to the gearing on the bevel gear is shown in **Fig. 12**.

Fig. 11. Damage to the bevel gear gearing.

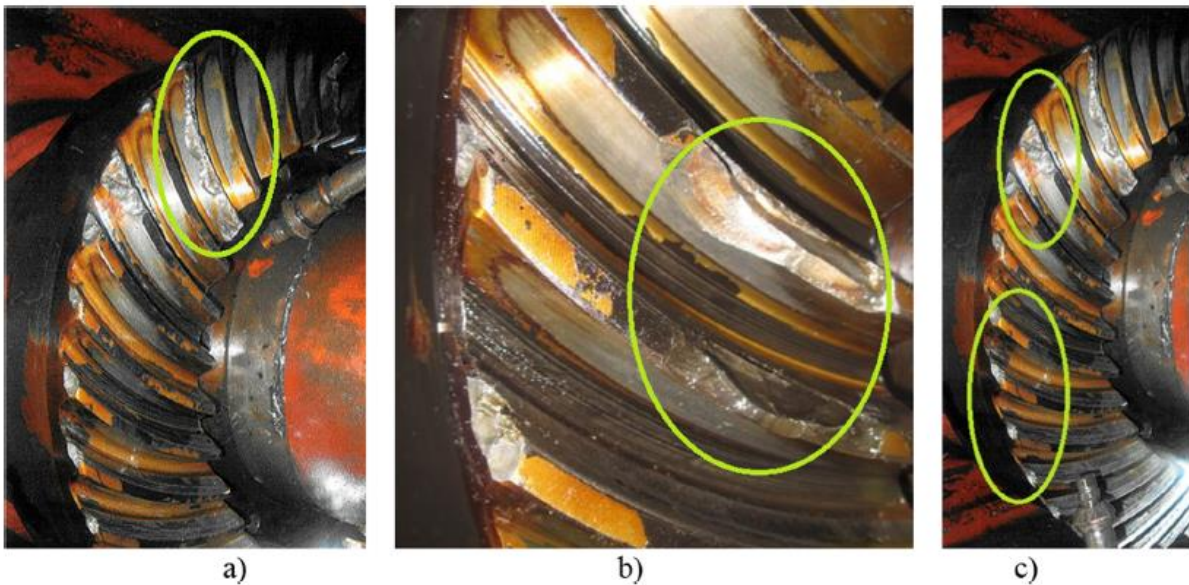
- Fracture of the tooth across the full width of the gearing (**Fig. 12a**). Three teeth out of the total number of teeth were damaged in this way. This is a fatigue fracture in the area above the root of the tooth, specifically in the area of the head of the tooth.
- On the gear, several teeth are broken off in the pitch area of the tooth length, from $\frac{1}{4}$ to $\frac{1}{2}$ of the tooth length (**Fig. 12b**). The cause of tooth fracture is fatigue damage to the material as a result of repeated bending stress on the tooth. The fracture starts on the tension-loaded side of the tooth by propagation of a small crack over a large number of loading oscillations. The fracture surface of the tooth shows two distinct zones, namely the initial and final fracture, with typical fatigue (fine-grained) and force (crystalline, rough) parts.

Fig. 12. Damage to bevel gear gearing a) fracture in the area of the tooth addendum across the width of the tooth, b) fracture in the middle of the width of the gearing, c) fracture of the tooth at the end of the width of the gearing.

In the fatigue zones, there are no obvious signs of plastic deformation. The surface of this part of the fracture is smooth, matte in appearance, with noticeable lines of a kind of crack propagation process.

- All gear teeth have broken off chunks of the tooth ends on the addendum side farthest from the centerline of the wheel-shaft (**Fig. 12c**). They are all bend stressed by variable loads at low cycle counts. When compared to pinion damage, there is no broken tooth and no chunk broken off at the head of a tooth. The pinion tooth ends are damaged and worn as are the teeth along their length. Fracture marks in the same type of fracture can vary widely from one location to another even over a small observed section. The fracture position of some teeth is predominantly granular, characterized by poorly visible plastic deformation in the part of the

fracture that is granular. The part of the fracture surface near the center of the fracture surface is duller, less or not at all granular with an elevation. The origin of the wear is at the location of the surface hardened layer. The fracture can identify the shear point, the plastic deformation point and the vulnerable fracture surface. These are predominantly semi-fragile to ductile fractures.

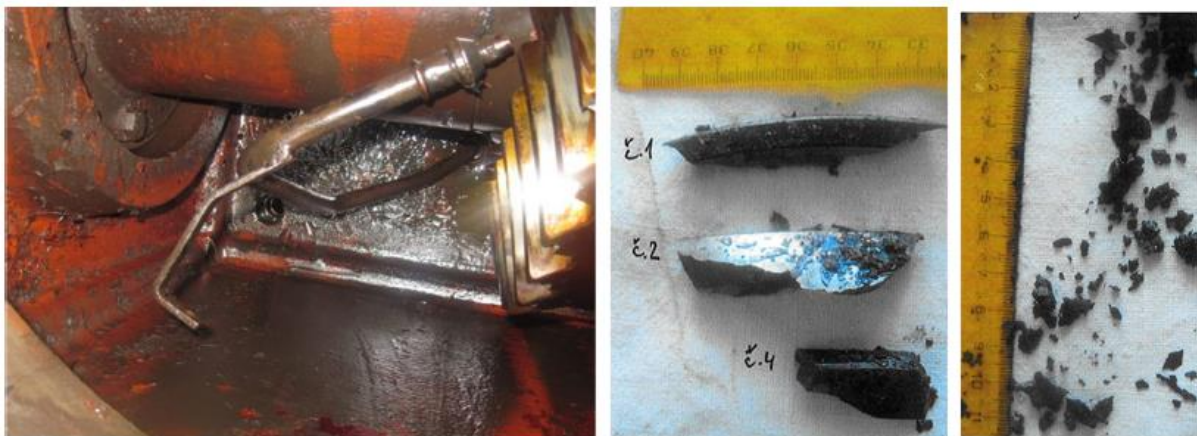
Another factor is the peeling of paint from the inner wall of the gearbox, which was getting into the inter-tooth space and deteriorating the lubrication (scales of hardened paint were pushing the oil out of the tooth contact area and disrupting the integrity of the oil film).

Fig. 13. Impurities and fragments from the gearbox.
