Study of the influence of surface treatment on the wear development under quasi-static loading of the levers of a newly designed thrust bearing

The article deals with the study of the influence of surface treatment on the development of wear and damage under quasi-static loading of the levers, which are critical parts of a newly designed axial bearing. The presented research has been carried out in two phases. In the first phase, basic samples that represented the types of geometries coming into contact in real conditions of bearing operation were manufactured and experimentally tested. Based on the results obtained at this stage, it was found that electroless nickel-plated samples showed the best results in terms of surface treatment. Due to this, real levers were produced in three sizes, which are estimated to have the potential for the greatest use in turbines, and these were surface treated with electroless nickel plating. In the second phase, the surface integrity and stiffness of the levers were examined. All samples and levers were made of 34CrNiMo6 steel. The evaluation was performed using stereomicroscope and a scanning electron microscope. Based on the results, it could

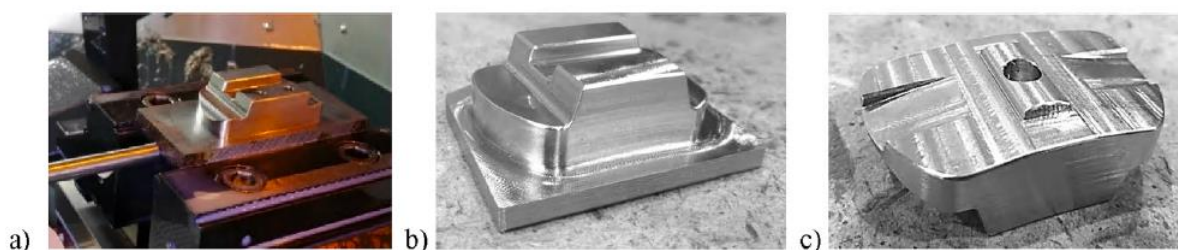
Fig. 12. (a) Process of the lever machining; (b) the lever after machining from one side; (c) machined lever.

The levers were manufactured using the DMU 40eVo linear milling centre. The machining strategies were chosen so that the workpiece was machined in two steps of fixing. Special clamping jigs for the first and second clamping positions have also been adapted to this strategy. The final height of the lever arm was measured with a probe with an accuracy of 0.1 µm. The resulting accuracy (when the clamping error was considered) was in the range of ±0.01 mm. Process of the lever machining, the lever after machining from one side and machined lever are shown in Fig. 12.

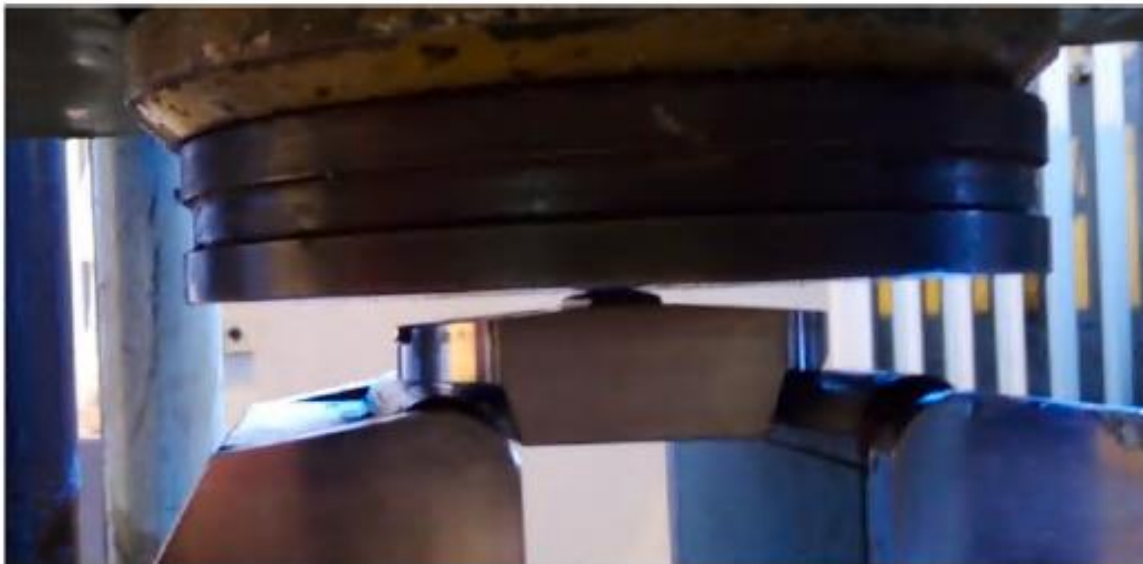
Fig. 13. Lever set-up during the pressure testing.

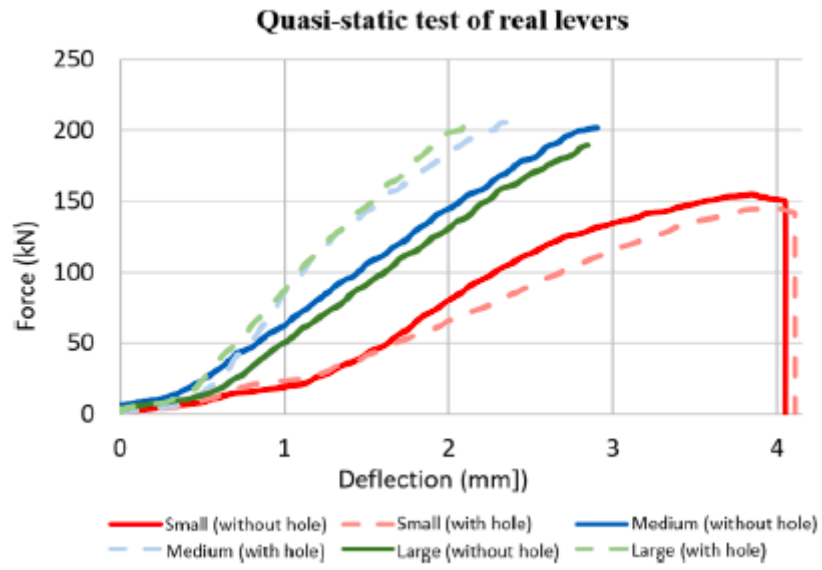
Fig. 25. Deflection development for all levers.

From the graph below (Fig. 25) it is evident that in the medium and large variants the stiffnesses are very similar, although the levers are quite different in size. The medium and large levers returned to their original shape after the end of the load (which was also verified on the granite slab), which means that the deformation of all levers was in the range of elastic deformations.

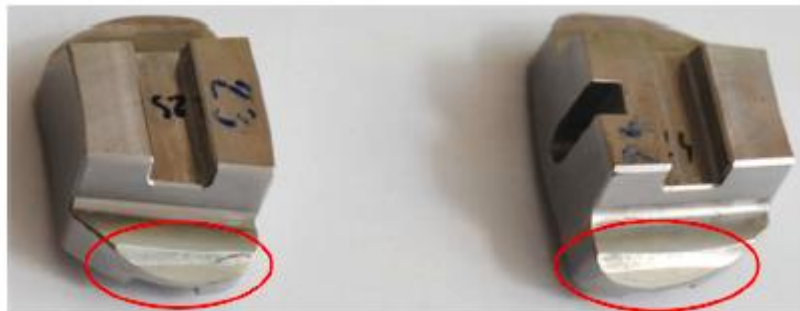
Fig. 26. Deformed small levers.

The smallest levers were no longer as rigid as the larger variants, and at about 150-160 kN plastic deformation had already occurred, as shown in Fig. 26. Then the test was interrupted because the lever arms slipped out of the jaws (documented by vertical line down in the graph in Fig. 26). However, it needs to be stated that the nominal load on the whole bearing in real practice, where the smallest variants of levers are used, is a maximum of ~130 kN. It is <11 kN per lever arm, so the safety factor is more than 10 times higher.

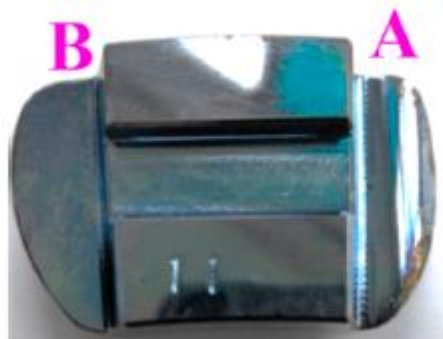
Fig. 27. A lever treated by electroless nickel plating before test.

Prior to the static test, areas A and B were marked on the levers (Fig. 27), which were documented on a scanning electron microscope. For all lever arms, these indicated areas have been retained, i. e. the cylindrical contact area is labelled “A”, the planar contact area is labelled B.
