Analysis of damage origin of bevel gear wheels

The problem is solved for a single-stage bevel gearbox with curved teeth, which is part of the mechanism of a small hydroelectric power plant. Due to the frequent failure rate of the bevel gears, as well as to determine the damage, vibrations were measured on this assembly.

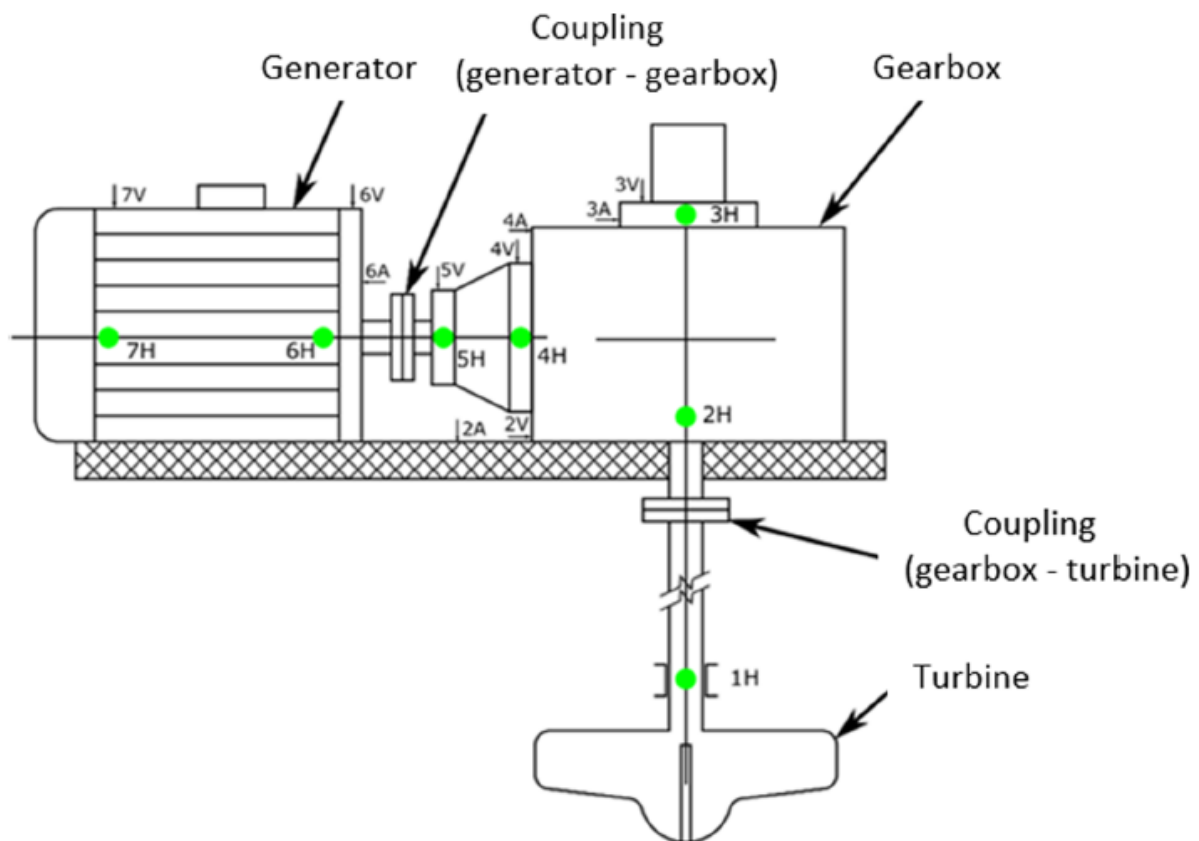
Due to the increased noise level of the TG 2 of the small hydropower plant, the vibrations on this plant were measured. A schematic of the measurements with the marking of the measurement points is shown in Fig. 2.

Total vibration, *FFT* spectra and Time record were measured. Measurement - data collection was carried out for each of the seven measurement points in three mutually perpendicular directions (*H* - horizontal, *V* - vertical, *A* - axial).

Fig. 2. Measurement diagram with marking of the measurement points on the TG2 turbogenerator (1-plain bearing, 2 - bearing of the vertical transmission shaft at the output, 3 - bearing of the vertical transmission shaft, 4 - bearing of horizontal transmission shaft near to the bevel pinion, 5 - bearing of the horizontal transmission shaft near to the coupling, 6 - the place on the generator closer to the coupling, 7 - the place on the left on the generator, measured directions: *H* - horizontal, *V* - vertical, *A* - axial).

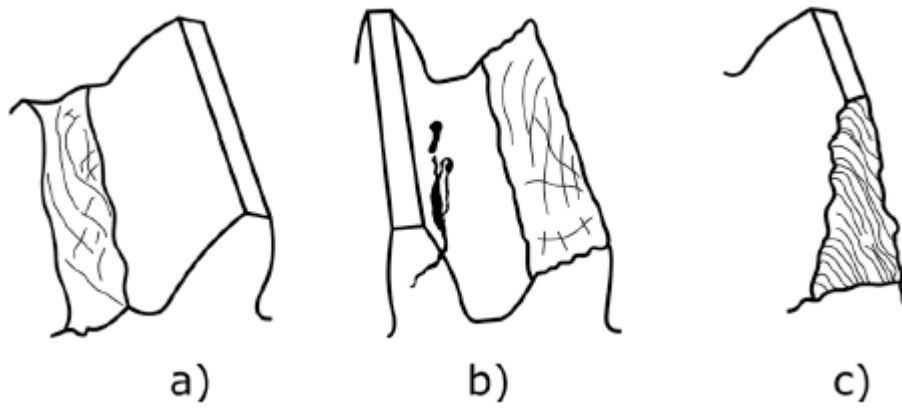
In **Fig. 3a** the fatigue fracture is at the tooth base. This fracture is typical in cemented gears under small overload. It starts at the region of maximum stress concentration. A smoother fatigue fracture surface is visible at the fracture face in the direction of the applied load force, continuing with a coarse fracture surface.

The fatigue fracture in the area above the tooth base (**Fig. 3b**) occurs most often at the point of contact fracture on the sides of the teeth. It occurs in hardened gears with a small layer thickness (nitrided,

nitride-cemented gear teeth). When a unilateral force is applied due to uneven loading in a light fit, fatigue fracture of a tooth part can occur (**Fig. 3c**).

Fig. 3. Tooth fractures: a) fatigue fracture at the base of the tooth, b) fatigue fracture in the area above the base, c) fatigue fracture of part of the tooth.

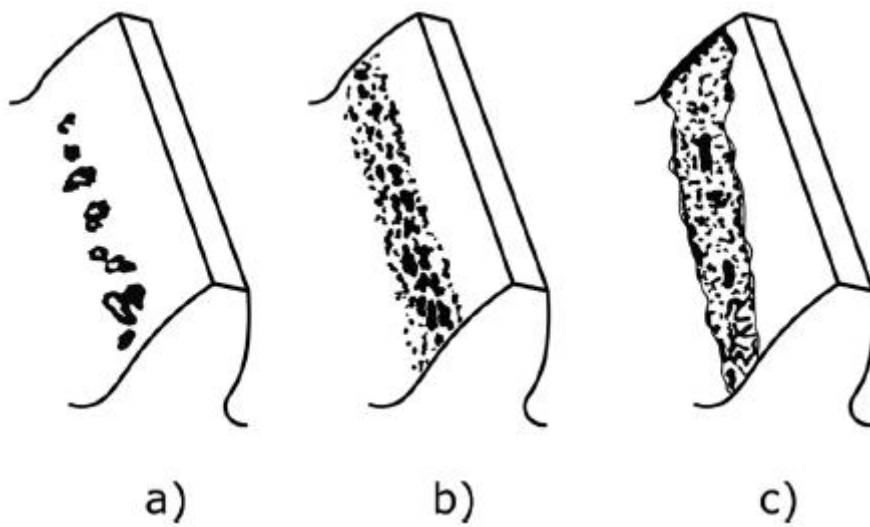
The tooth flanks are subjected to cyclic contact stresses, which induce typical fatigue wear - pitting - when the limit value is exceeded and a certain number of cycles is reached (**Fig. 4a**). Pitting is usually circular in shape and is usually located in the negative slip region below the rolling point [**21,22**]. The onset of tooth flank damage is signaled by an increase in noise and drive vibration, which gradually increases. Deep pitting occurs in refined gearing with higher strength. Pitting can be delayed by increasing the strength of the gearing material or by using one of the surface hardening methods.

In steel gears of formed and cast soft wheels (material ultimate strength limit $R_m < 500$ MPa) and in gears of quality alloys (ductile cast iron), a large number of small pittings often occur in the area below the rolling point under load over a wide interval around the contact fatigue limit (**Fig. 4b**).

On the sides of the gearing of nitrided and carbonitrided gears, roughening often occurs in the area of allowable stress (**Fig. 4c**), which is related to peeling of the surface coating. Pitting often occurs later in this roughened area.

Fig. 4. Tooth pitting: a) Pitting - alloy steel ($R_m = 900$ MPa), b) Pitting - hardened cast iron, mild steel ($R_m < 500$ MPa), c) Pitting (nitrided gearing).

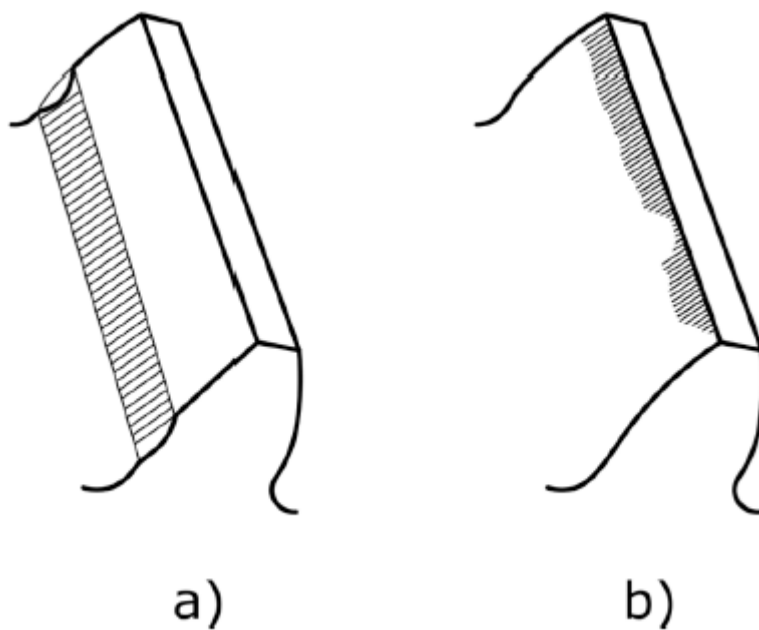
For soft steel and ductile cast-iron wheels, there is often occurrence accompanied with minor pitting of plastic deformation (**Fig. 5a**). This is a sign of gearing overload, shock and oscillation [**24**]. Plastic pitting can be observed in the rolling point region, plastic elongation of the tooth head means unbalanced slip ratios and large friction forces in this region [**25,26**].

Fig. 5. a) Plastic deformation (ductile cast-iron, soft steel), b) Tooth flank jamming.

In contrast to fatigue contact damage to the tooth flanks, gear jamming often occurs during transmission run-in. Light jamming has a small range and is manifested by fine grooves in the slip direction. When the load is reduced and the run-in is gradual, it may disappear after some time. **Fig. 5b** shows the damage to the tooth flanks caused by jamming. The indentation marks on the heads of the teeth are indicative of misaligned ratios in this area and insufficient lubrication. The depth and character of the indentations depend on the hardness of the tooth flanks and on the level of loading.

Jamming that extends to the entire contact surface may result in the wheel being taken out of service. The working flanks of the teeth are often destroyed by coarse indentations and plastic creep.

We can limit the tendency of the teeth to jam by selecting the appropriate combination of material and lubricating oil, reducing the allowable pressure and designing a correction to compensate for the dimensional slips.

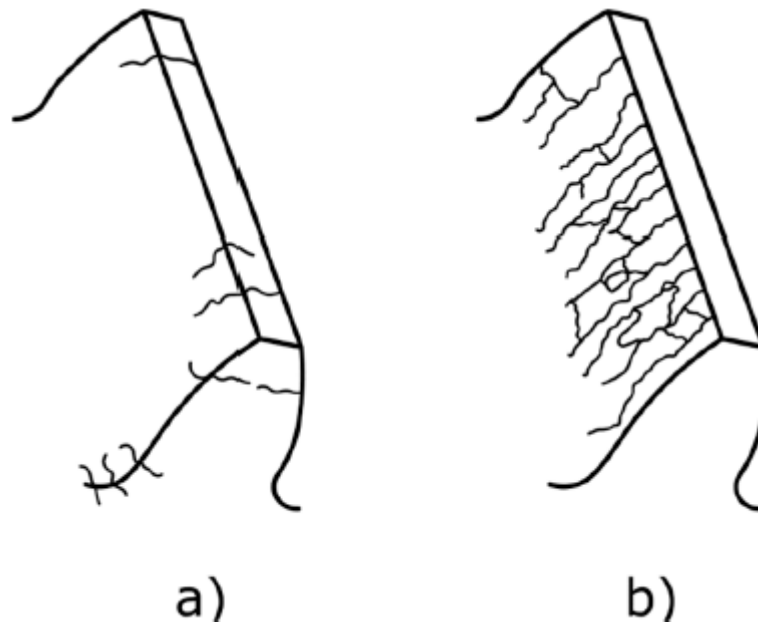
Fig. 6. a) Cracks after hardening, b) cracks after grinding.

Cracks after hardening (**Fig. 6a**) most often originate from the edges of the teeth. It can be oriented in the direction of the meshing, but also in a direction perpendicular to the meshing. They occur in cemented and surface hardened gears [29].

In cemented gears with a supersaturated coating, grinding cracks occur on the flanks of the teeth (**Fig. 6b**).
